Manhole Inspection Summary

Manhole # S07GG2008MH

Insp Date: **7/24/06 2:07 PM**

Location Address: **6202 LINCOLN AVE**

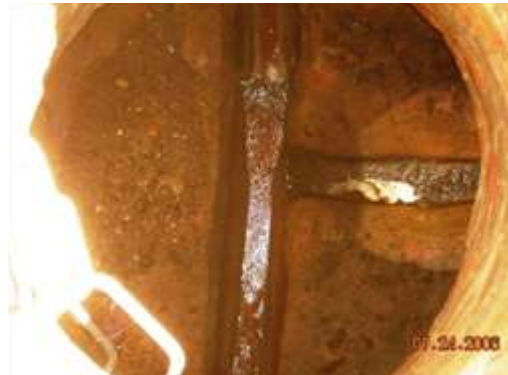
Top View

Evidence of surcharge - Bench debris.

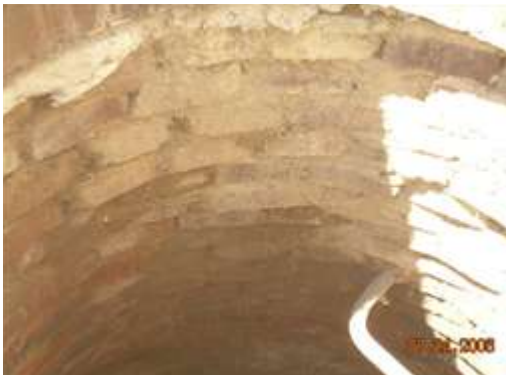
Defect

Condition: ☐ Sound ☐ Cracked ☐ Root Intrusion ☐ Loose Brick ☒ **Deteriorated**

Infiltration: ☐ None ☒ **Joint** ☐ Cracks ☒ **Mortar** ☐ Roots ☐ Wall

Infiltration: ☐ None ☐ Joint ☐ Cracks ☒ **Mortar** ☐ Roots ☒ **Wall**

Adjustment deterioration and infiltration.
Corbel and Barrel infiltration.

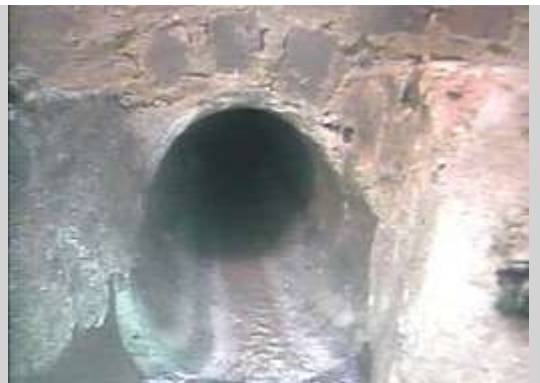
Pipe Out @ 12 O'Clock

Infiltration: **Evidence** Pipe Seal Cond: **Unknown**

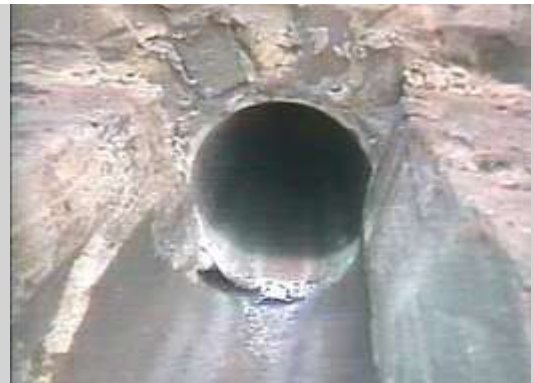
Pipe In @ 6 O'Clock

Barrel deterioration and infiltration. Channel deterioration.

Infiltration: **Evidence**

Pipe Seal Cond: **Cracked**
